## STM32L496xx/4A6xx device errata

This document applies to the part numbers of STM32L496xx/4A6xx devices and the device variants as stated in this page. It gives a summary and a description of the device errata, with respect to the device datasheet and reference manual RM351. Deviation of the real device behavior from the intended device behavior is considered to be a device limitation. Deviation of the description in the reference manual or the datasheet from the intended device behavior is considered to be a documentation erratum. The term “errata” applies both to limitations and documentation errata.

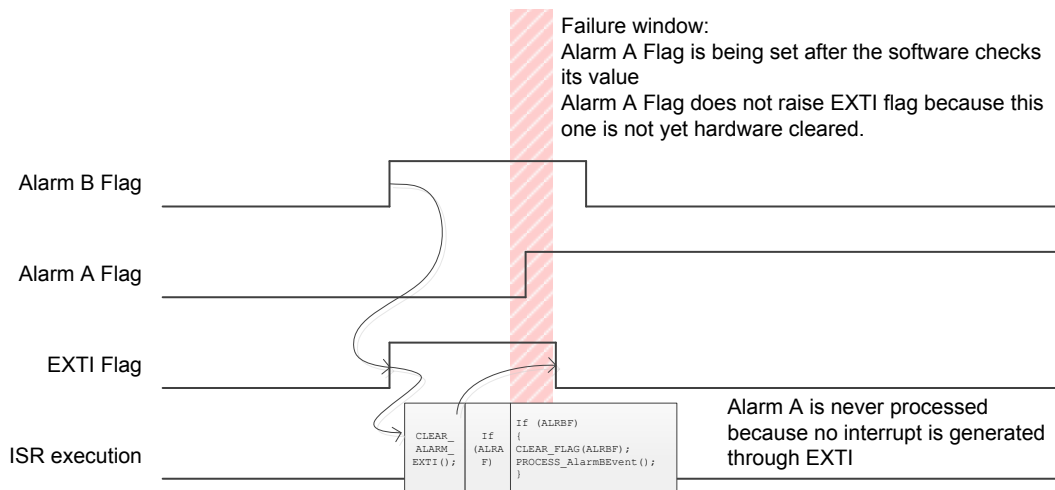
Figure 1. Masked RTC interrupt

The following code example and figure illustrate the failure mechanism: The Alarm A event is lost (fails to generate interrupt) as it occurs in the failure window, that is, after checking the Alarm A event flag but before the effective clear of the EXTI interrupt flag by hardware. The effective clear of the EXTI interrupt flag is delayed with respect to the software instruction to clear it.

In the interrupt service routine, apply three consecutive event flag checks - source one, source two, and source one again, as in the following code example:
