## STM32WB55xx/STM32WB35Cx device errata

This document applies to the part numbers of STM32WB55xx/STM32WB35Cx devices and the device variants as stated in this page.

It gives a summary and a description of the device errata, with respect to the device datasheet and reference manual RM0434.

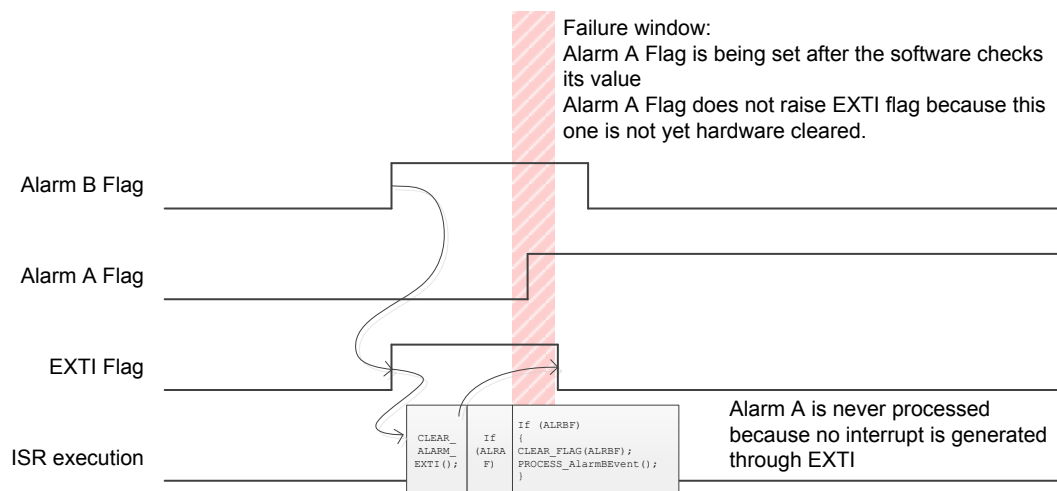
Figure 2. Masked RTC interrupt

The following code example and figure illustrate the failure mechanism: The Alarm A event is lost (fails to generate interrupt) as it occurs in the failure window, that is, after checking the Alarm A event flag but before the effective clear of the EXTI interrupt flag by hardware. The effective clear of the EXTI interrupt flag is delayed with respect to the software instruction to clear it.

In the interrupt service routine, apply three consecutive event flag checks - source one, source two, and source one again, as in the following code example:
